五邑工商總會學校

FIVE DISTRICTS BUSINESS WELFARE
ASSOCIATION SCHOOL

Roof Heat Rejected Coating – Test Report

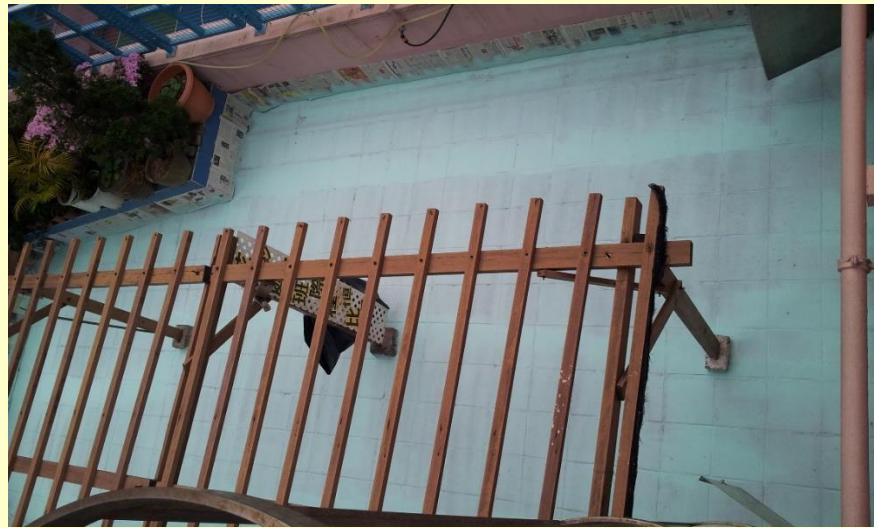
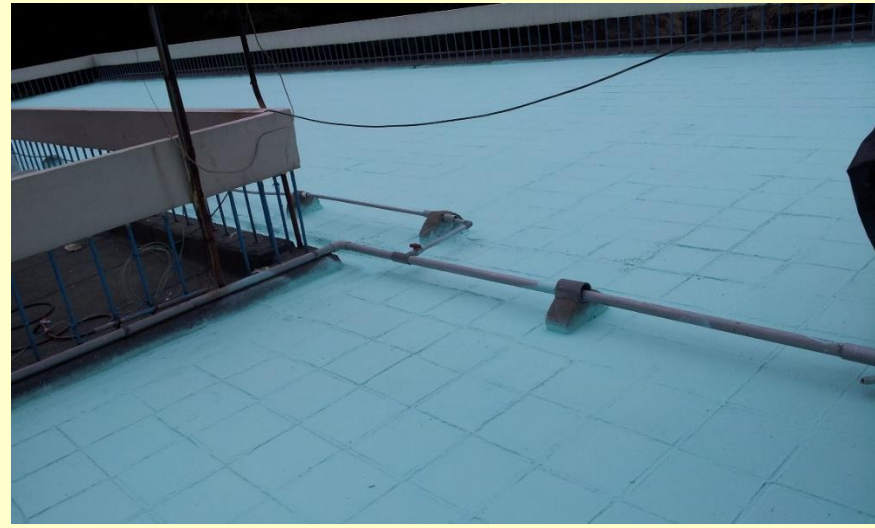
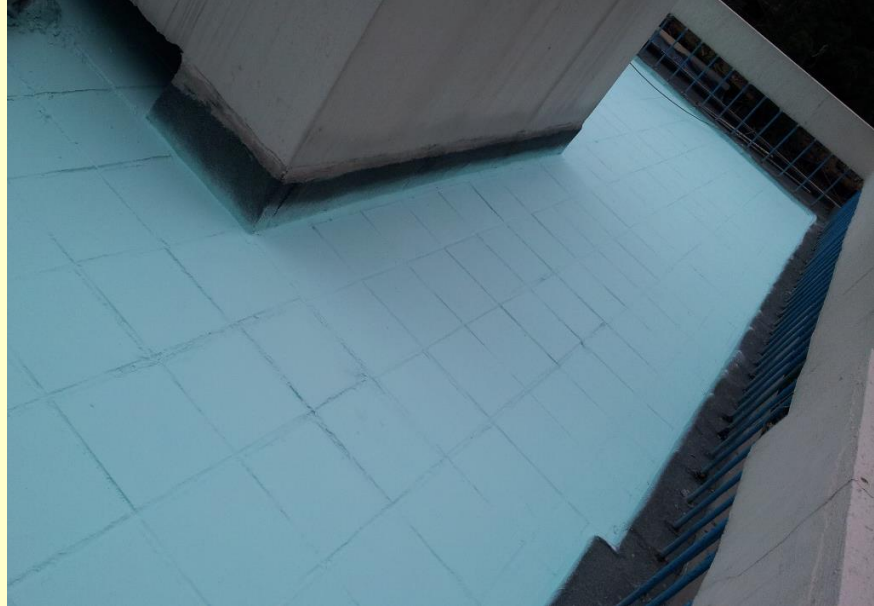
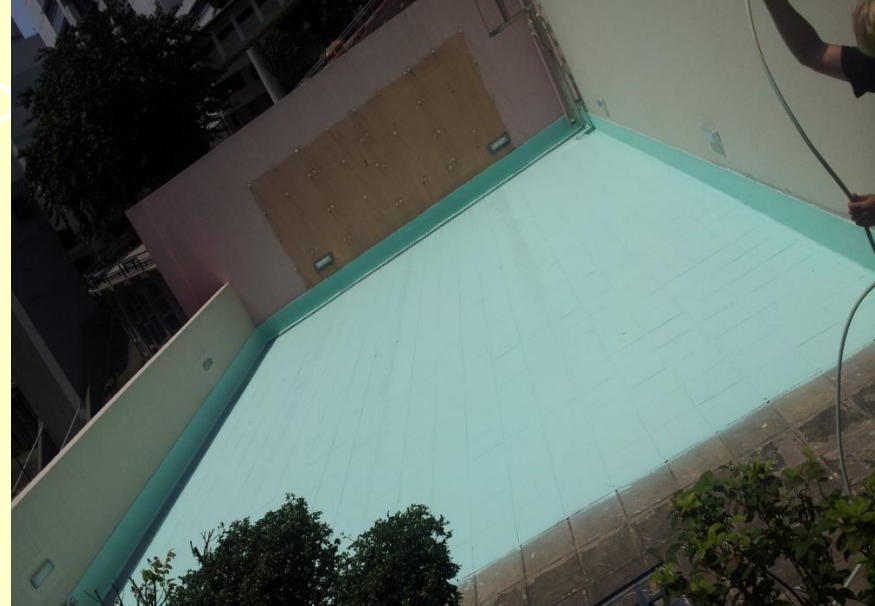
(The locations where had been applied with the Roof Heat Rejected Coating)

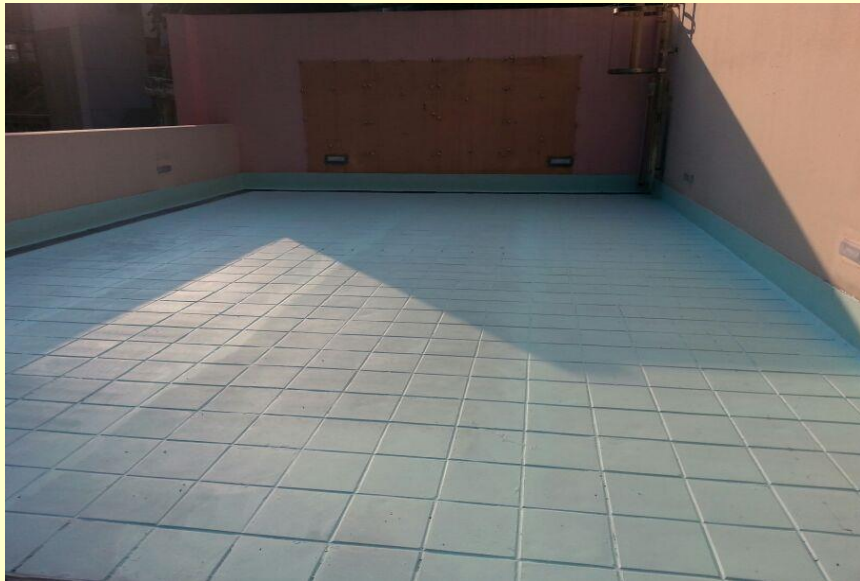
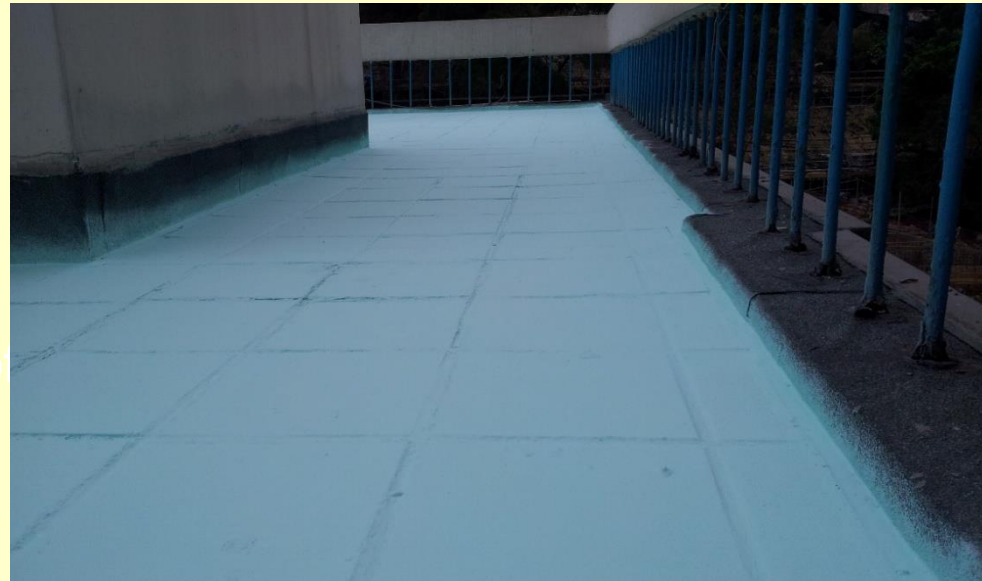
(The locations where had been applied with the Roof Heat Rejected Coating)

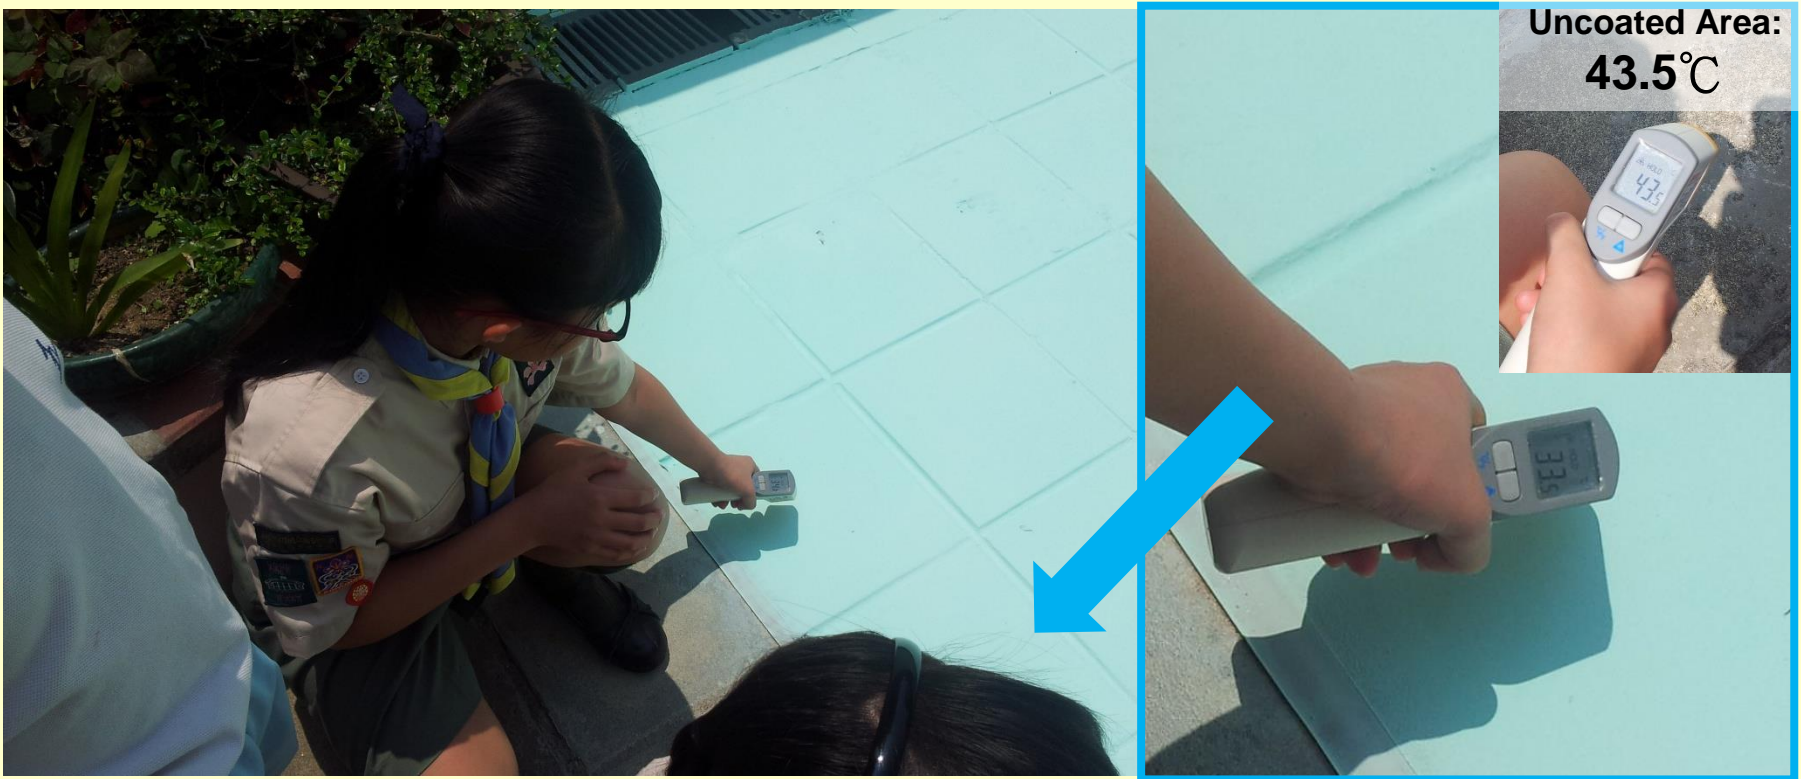
Temp. Test: **After Roof Heat Rejected Coating was applied**

Temperature Recorded: 33.5°C (coated) , 43.5°C (uncoated)

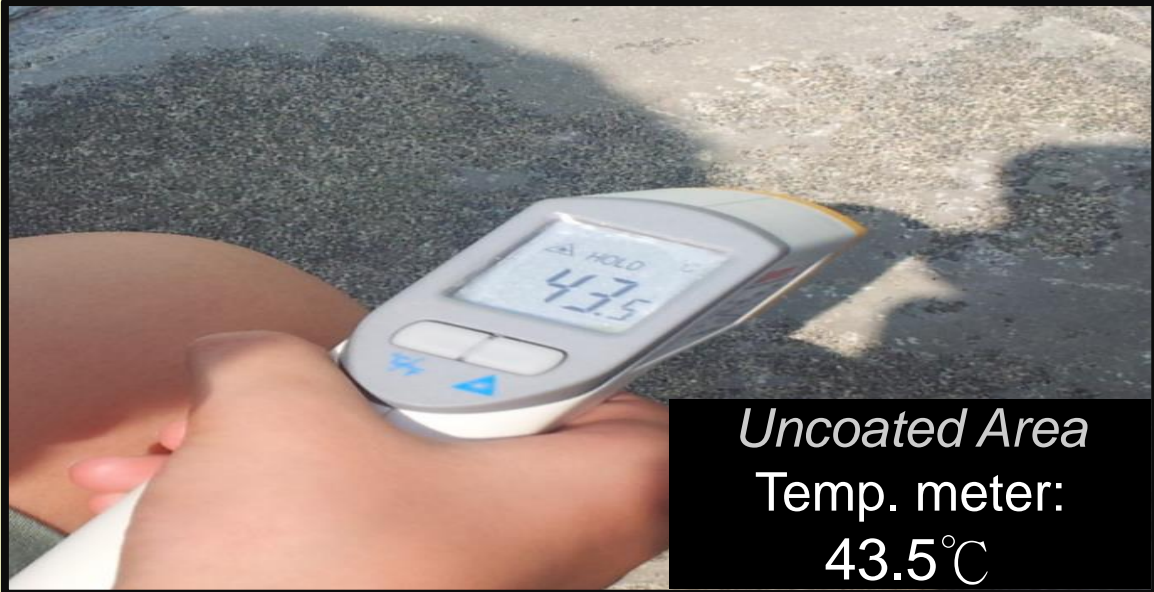
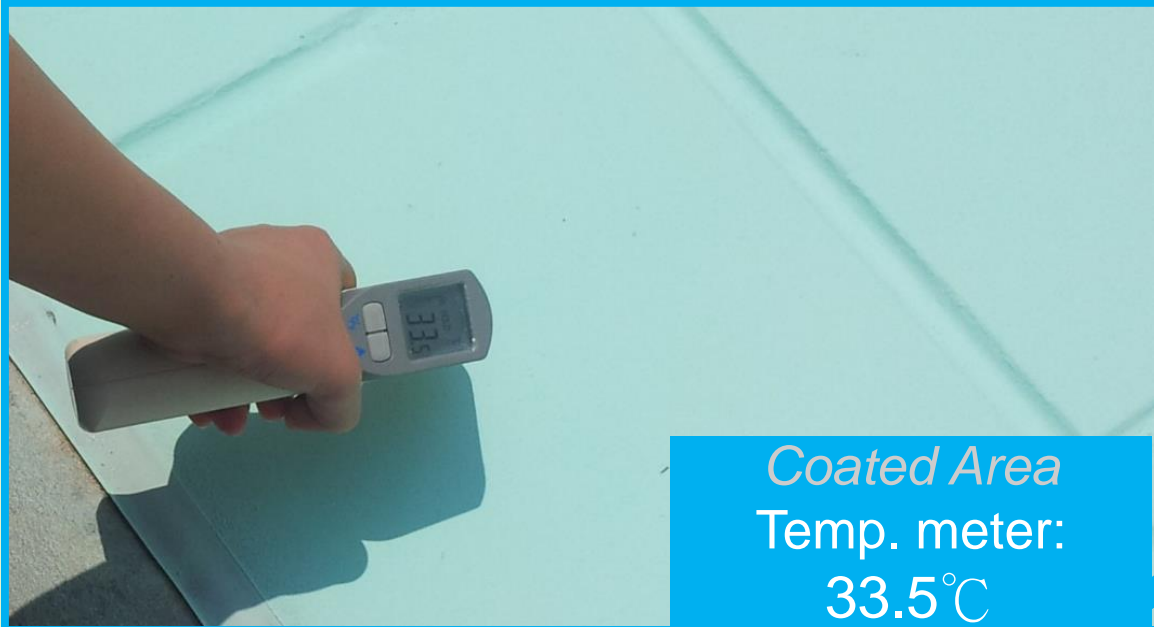
Temperature Test: *Uncoated VS Coated* roof area

Temperature Reduced:
10°C
