Sam Shui Natives Association Huen King Wing School

Test Report –

Solar Control Film

Roof Heat Rejected Coating

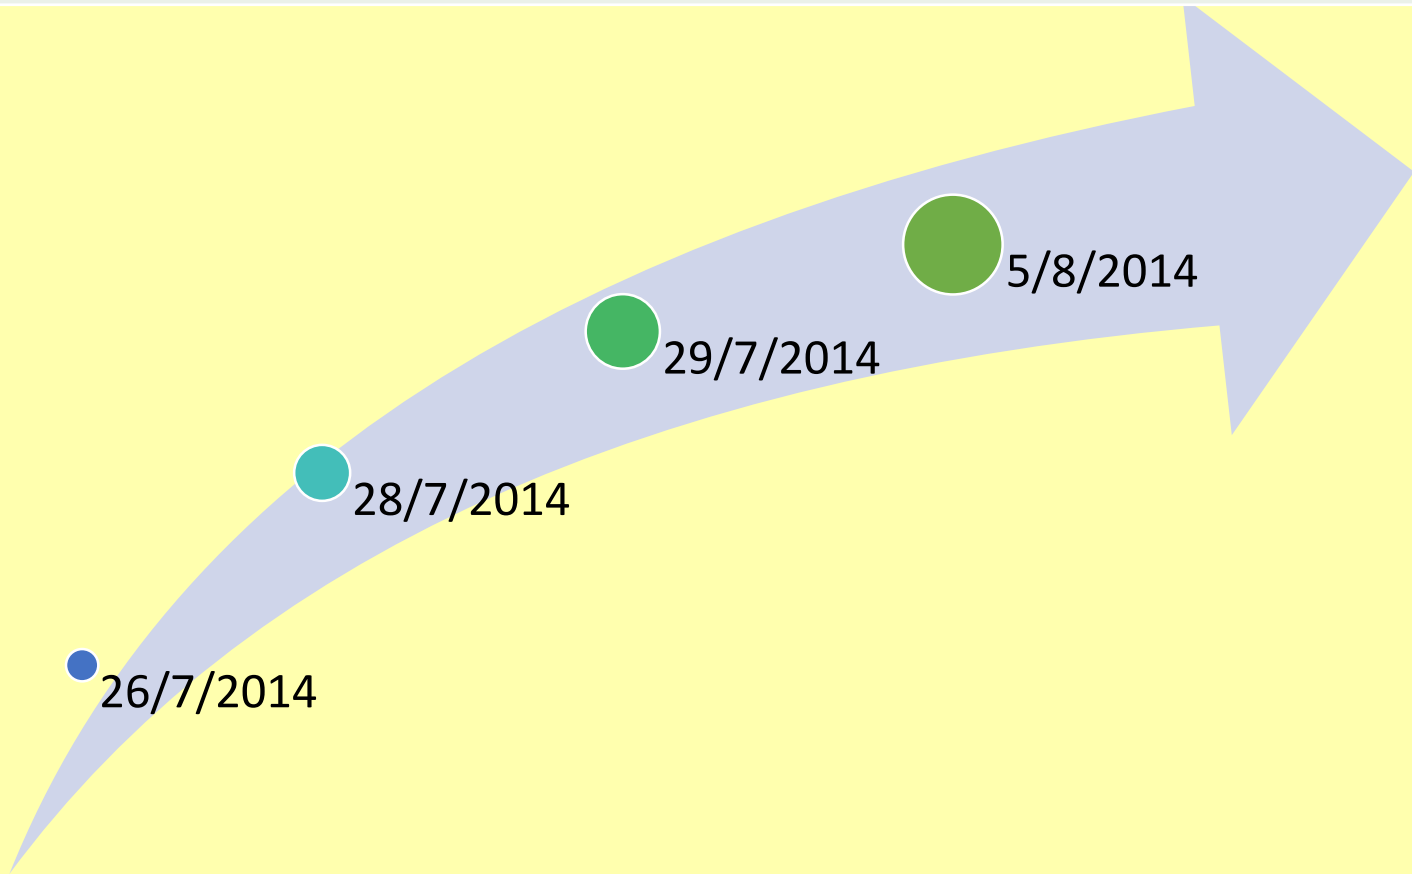
501	502
Before installation of solar control film	After installation of solar control film
Area: In front of the Blackboard & window

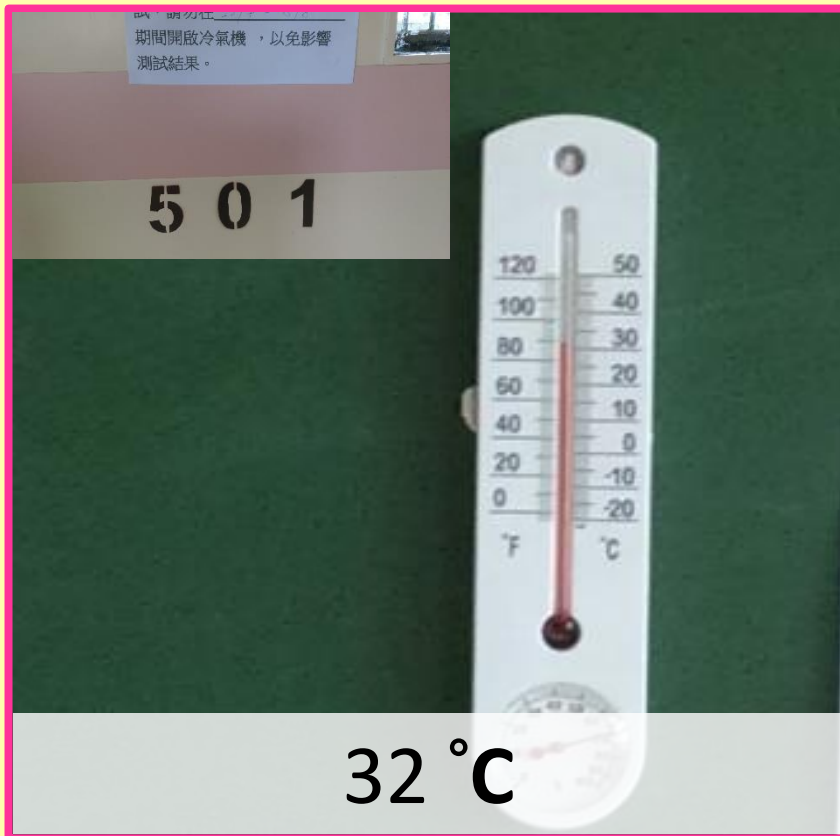
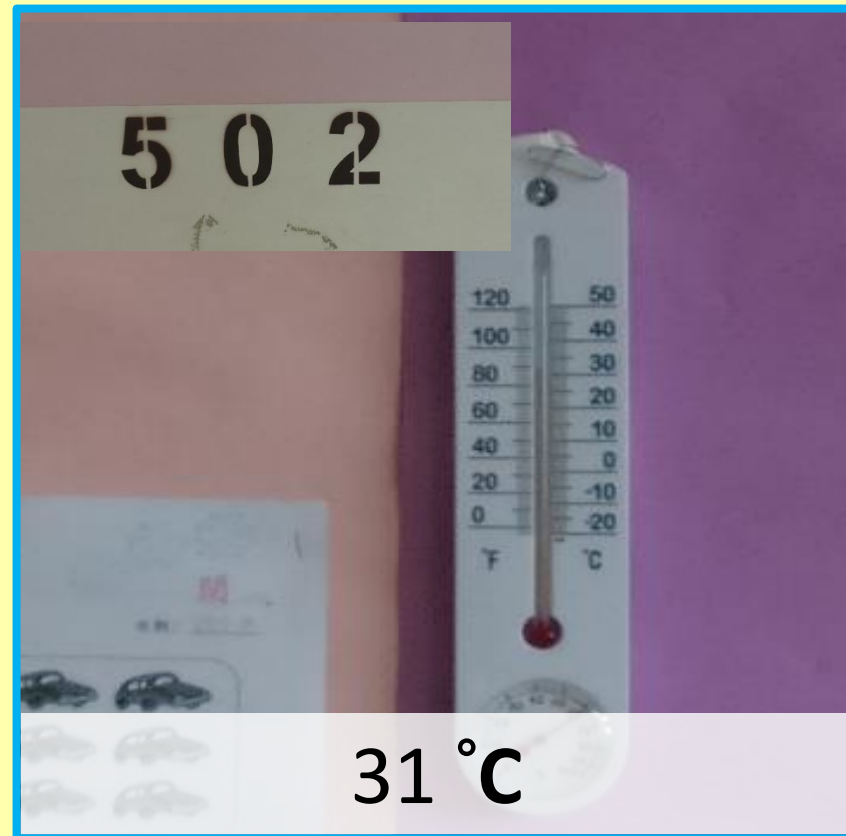
Without Window Film

With Window Film

***Because the backboard location is quite far away from the window, therefore, there will not have big difference before or after installation ***

Date: 26th July, 2014

Film model: CXP80

Total Solar Energy Rejected: 44%

Visible Light Transmittance: 80%

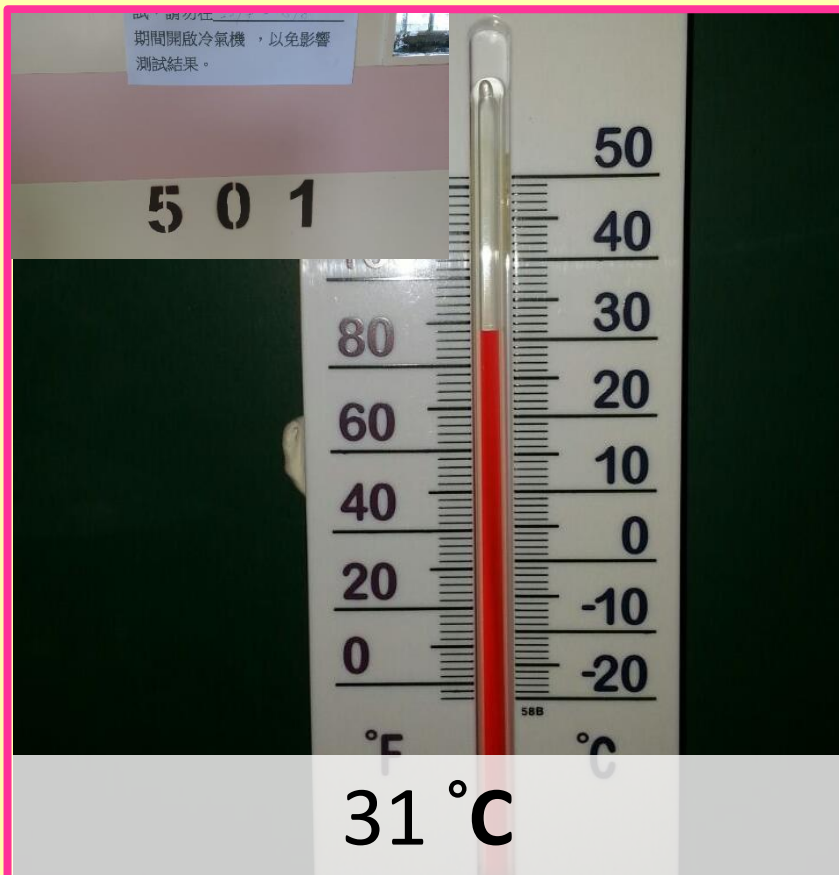
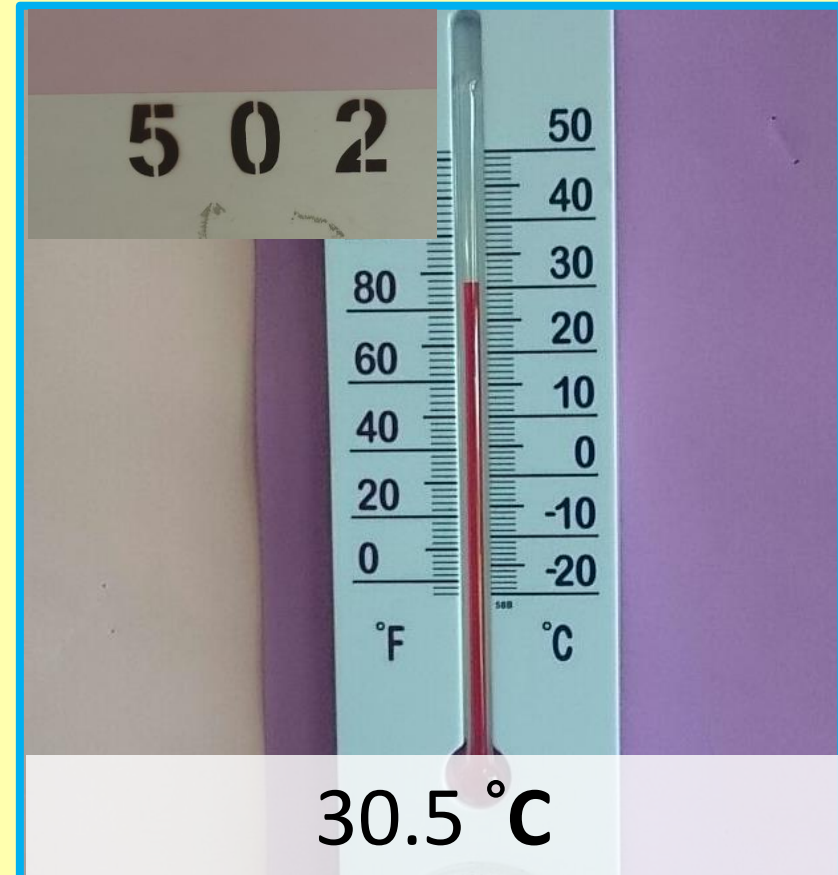
Without Window Film

With Window Film

***Because the backboard location is quite far away from the window, therefore, there will not have big difference before or after installation ***

Date: 28th July, 2014

Film model: CXP80

Total Solar Energy Rejected: 44%

Visible Light Transmittance: 80%

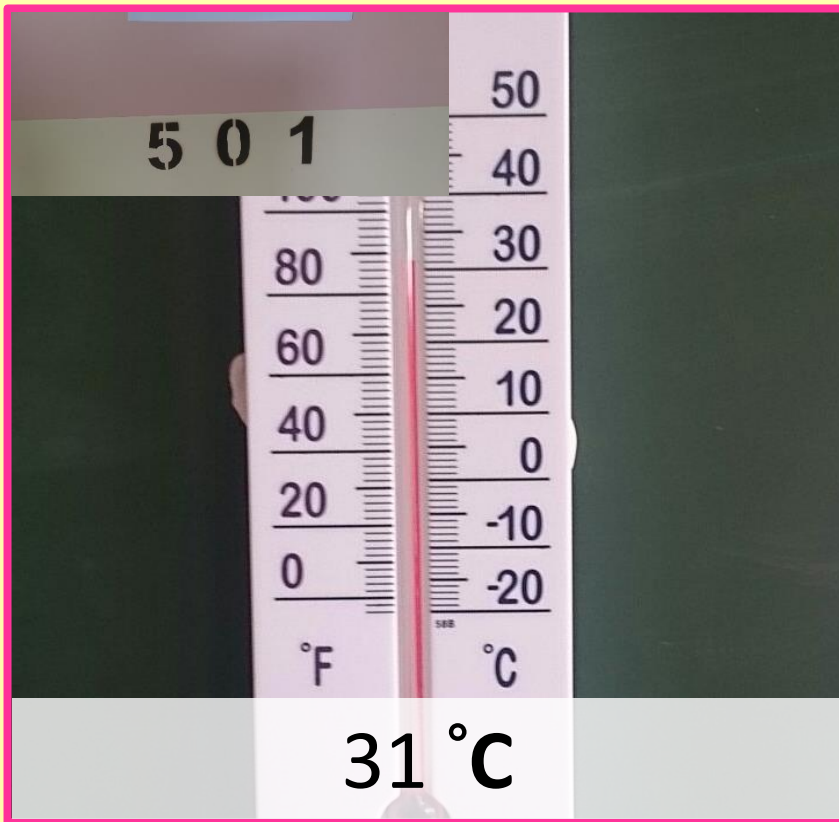
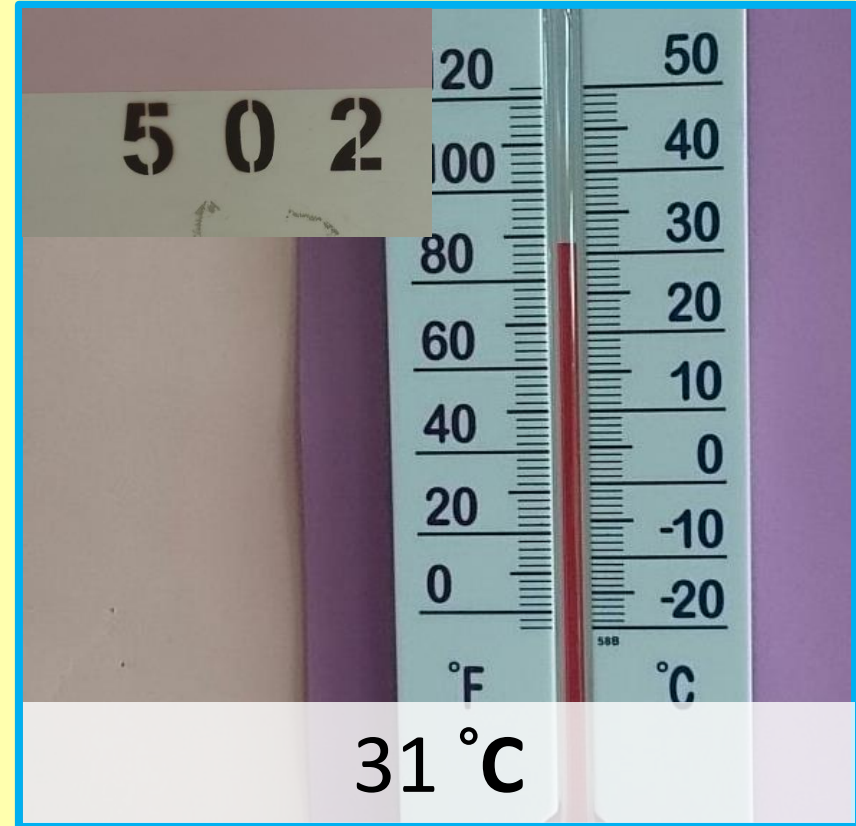
Without Window Film

With Window Film

***Because the backboard location is quite far away from the window, therefore, there will not have big difference before or after installation ***

Date: 29th July, 2014

Film model: CXP80

Total Solar Energy Rejected: 44%

Visible Light Transmittance: 80%

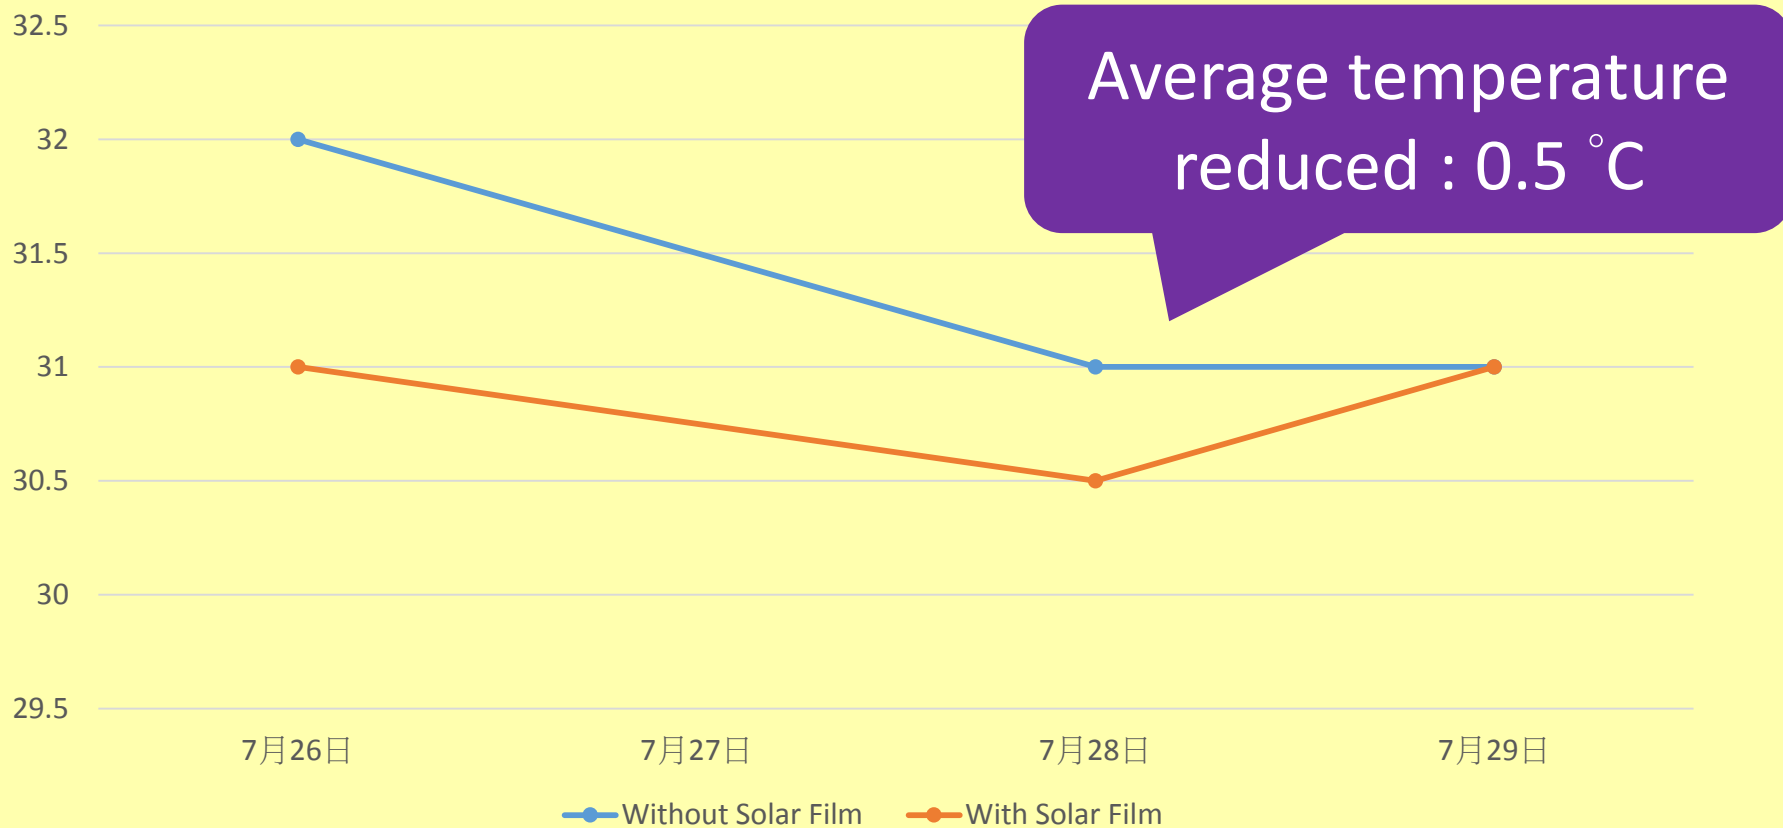
Location : blackboard

***Because the blackboard location is quite far away from the window, therefore, there will not have big difference before or after installation ***

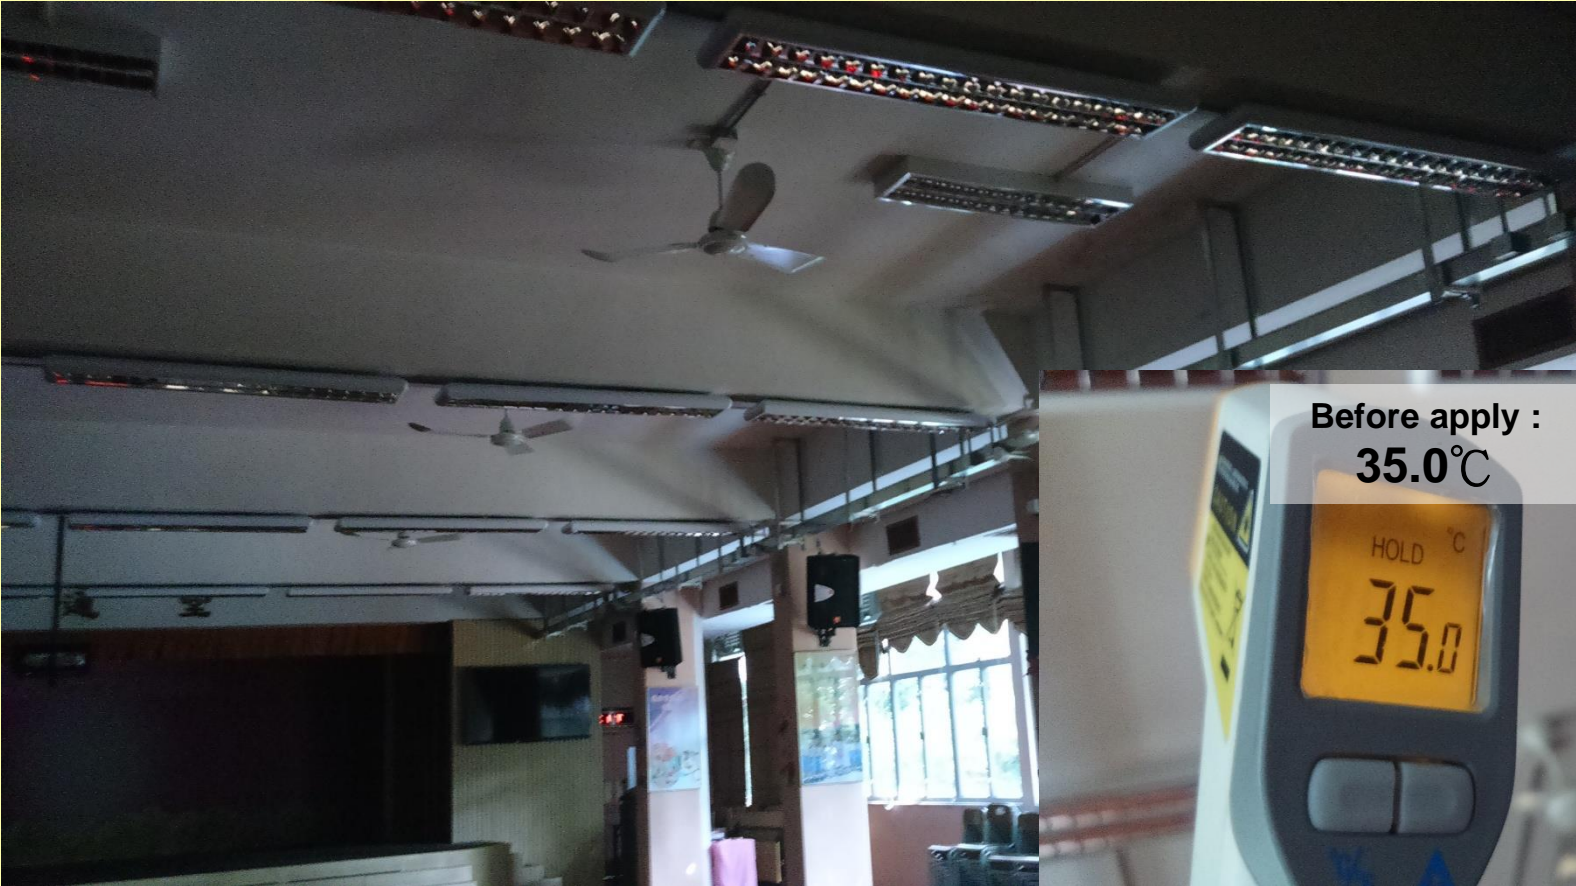
Temp. Test: **Before Roof Heat Rejected Coating was applied**

Location: 1/F (Hall under the roof)

Temperature Recorded: 33°C (after apply the coating)
35°C (Before apply the coating)

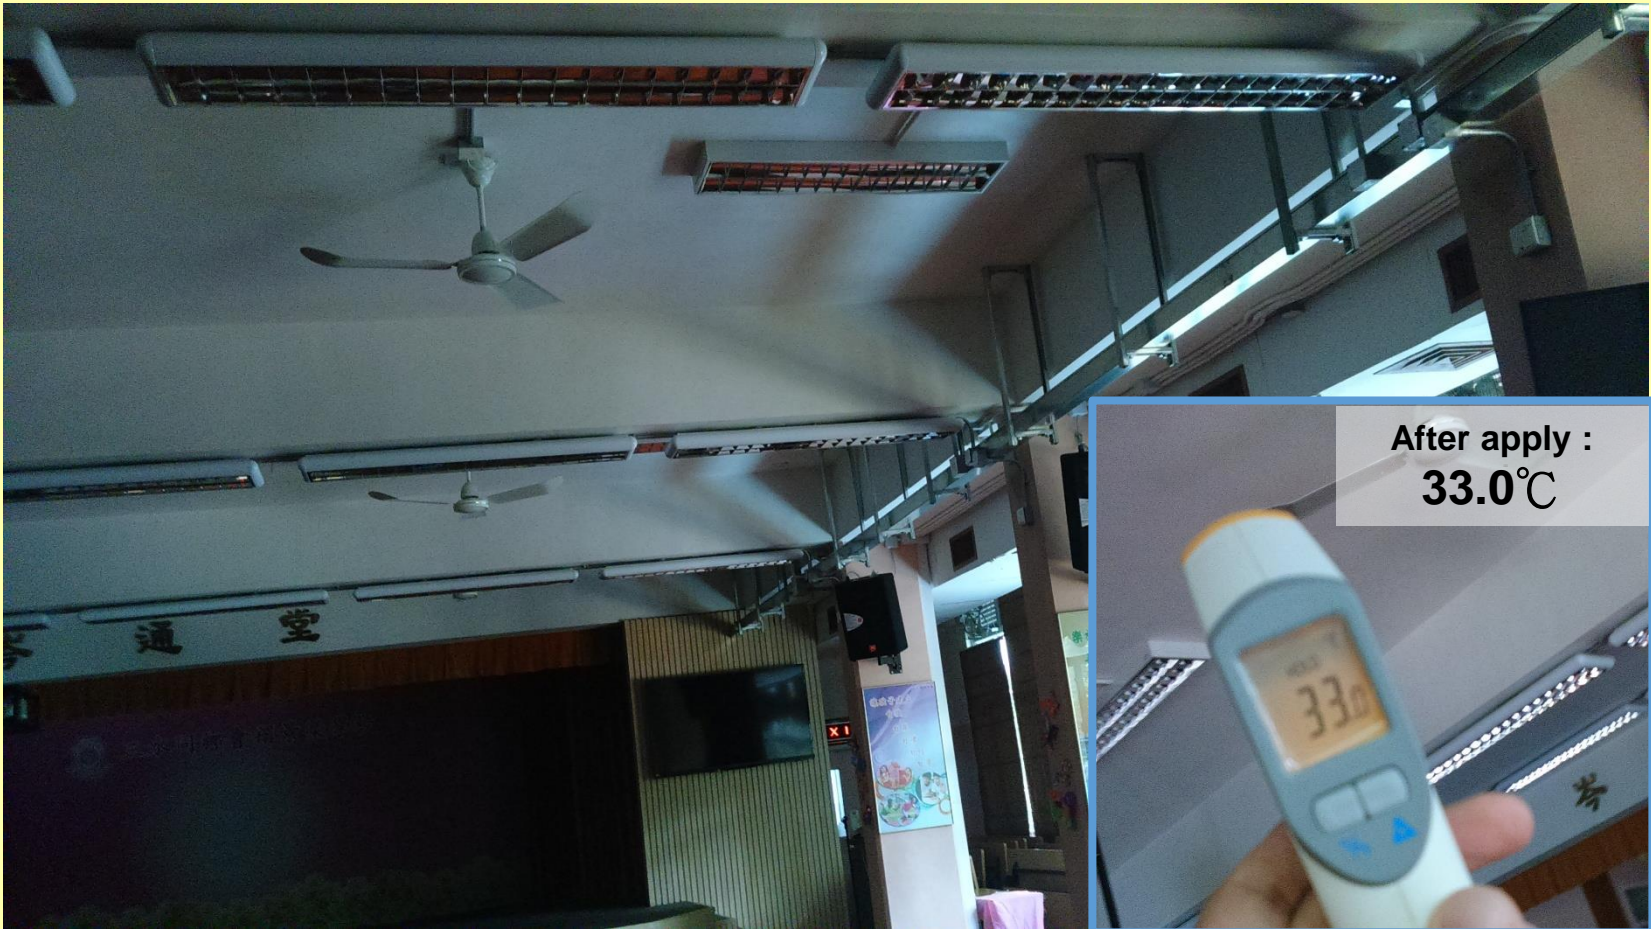
Temp. Test: **After Roof Heat Rejected Coating was applied**

Location: 1/F (Hall under the roof)

Temperature Recorded: 33°C (after apply the coating)
35°C (Before apply the coating)

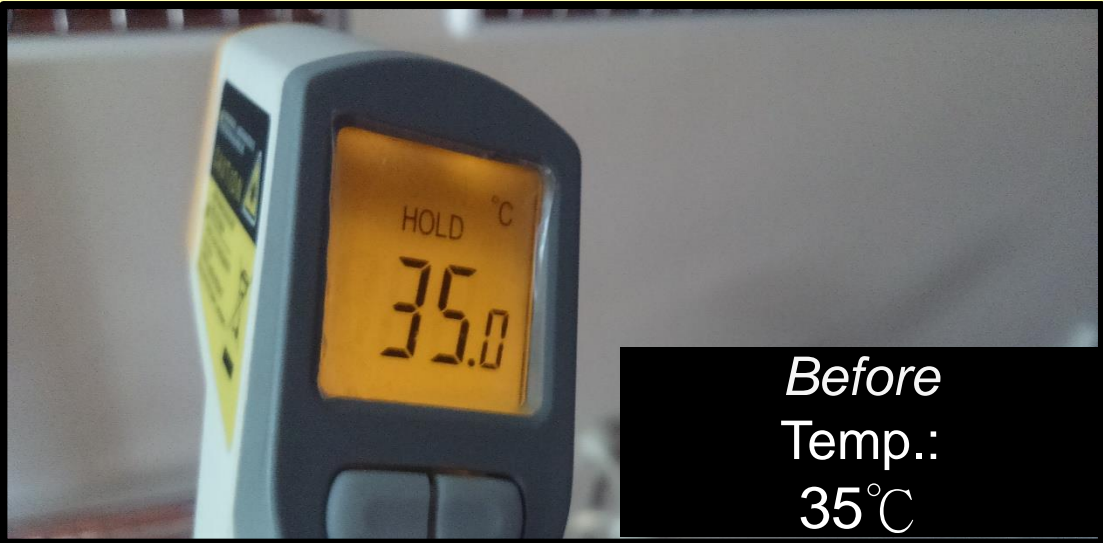
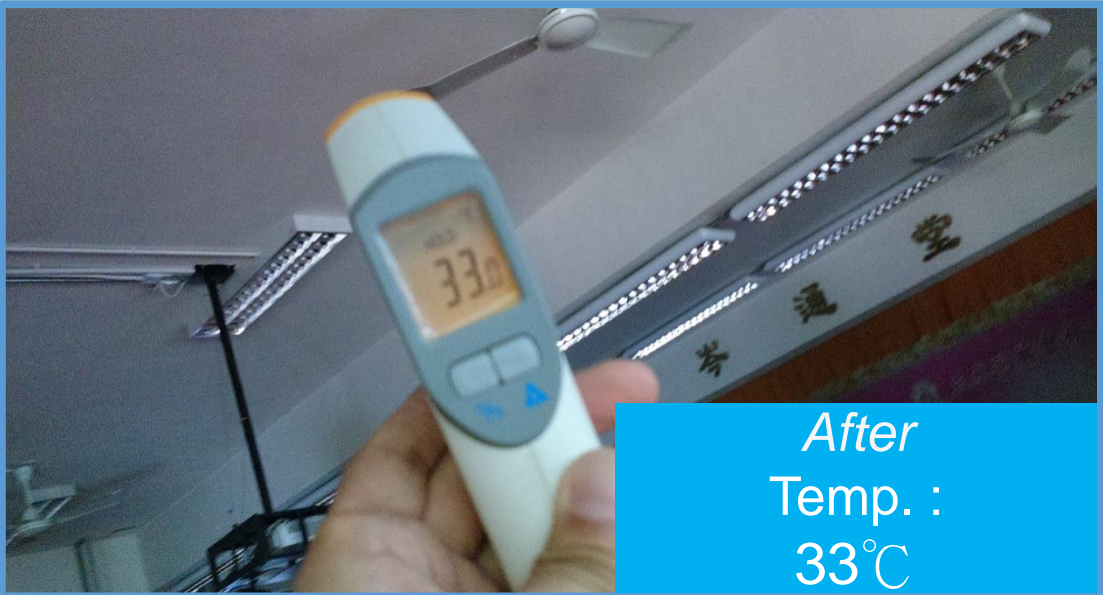
Location: 1/F (Hall under the roof)

Temperature Reduced:
2°C

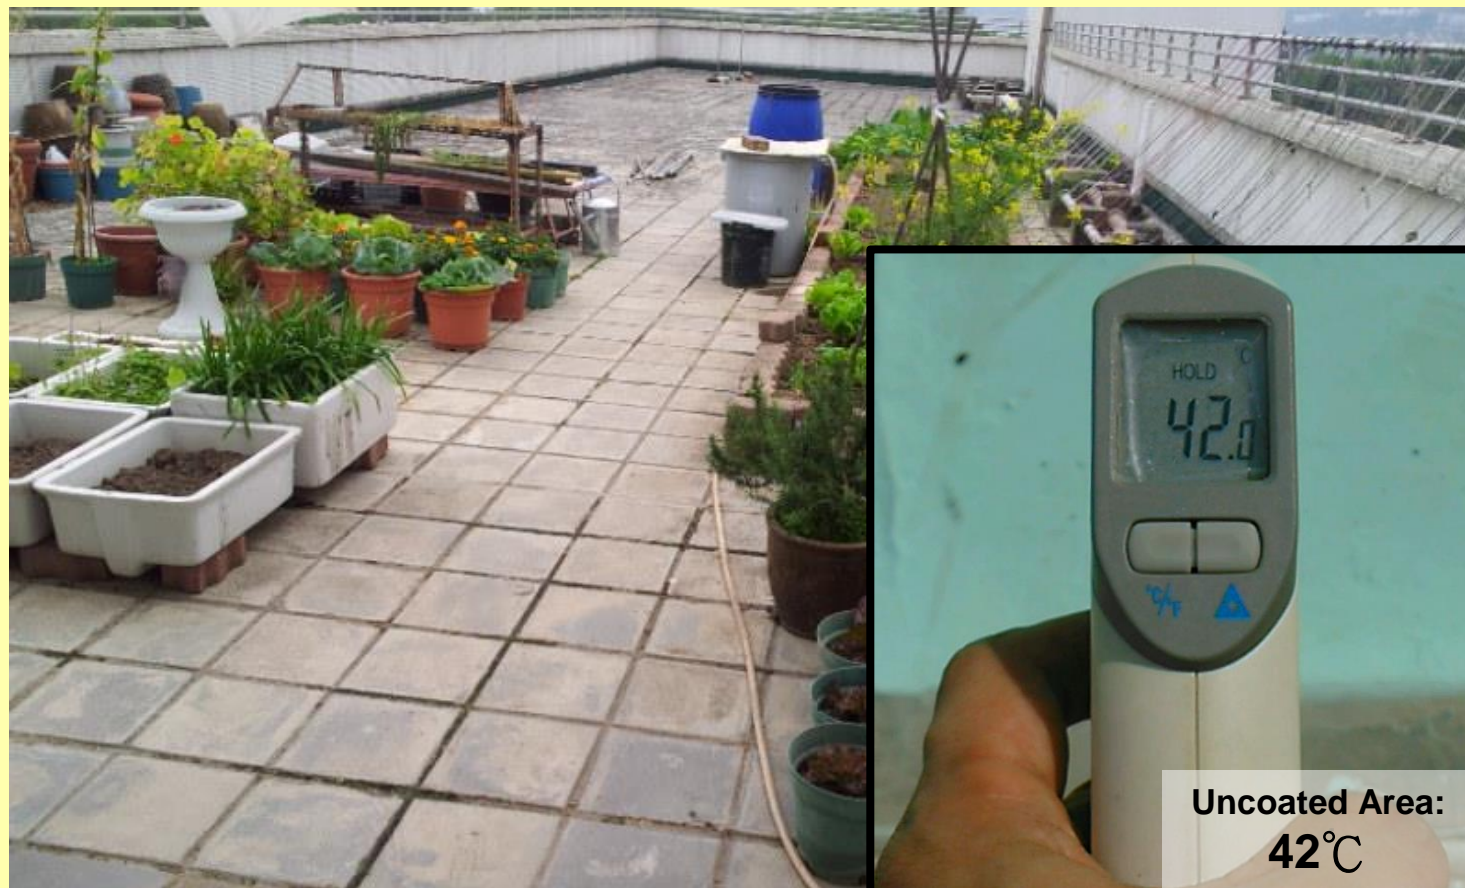
Temp. Test: **Before Roof Heat Rejected Coating was applied**

Location: 7/F (School's roof surface)

Temperature Recorded: 36°C (after apply the coating)

42°C (Before apply the coating)

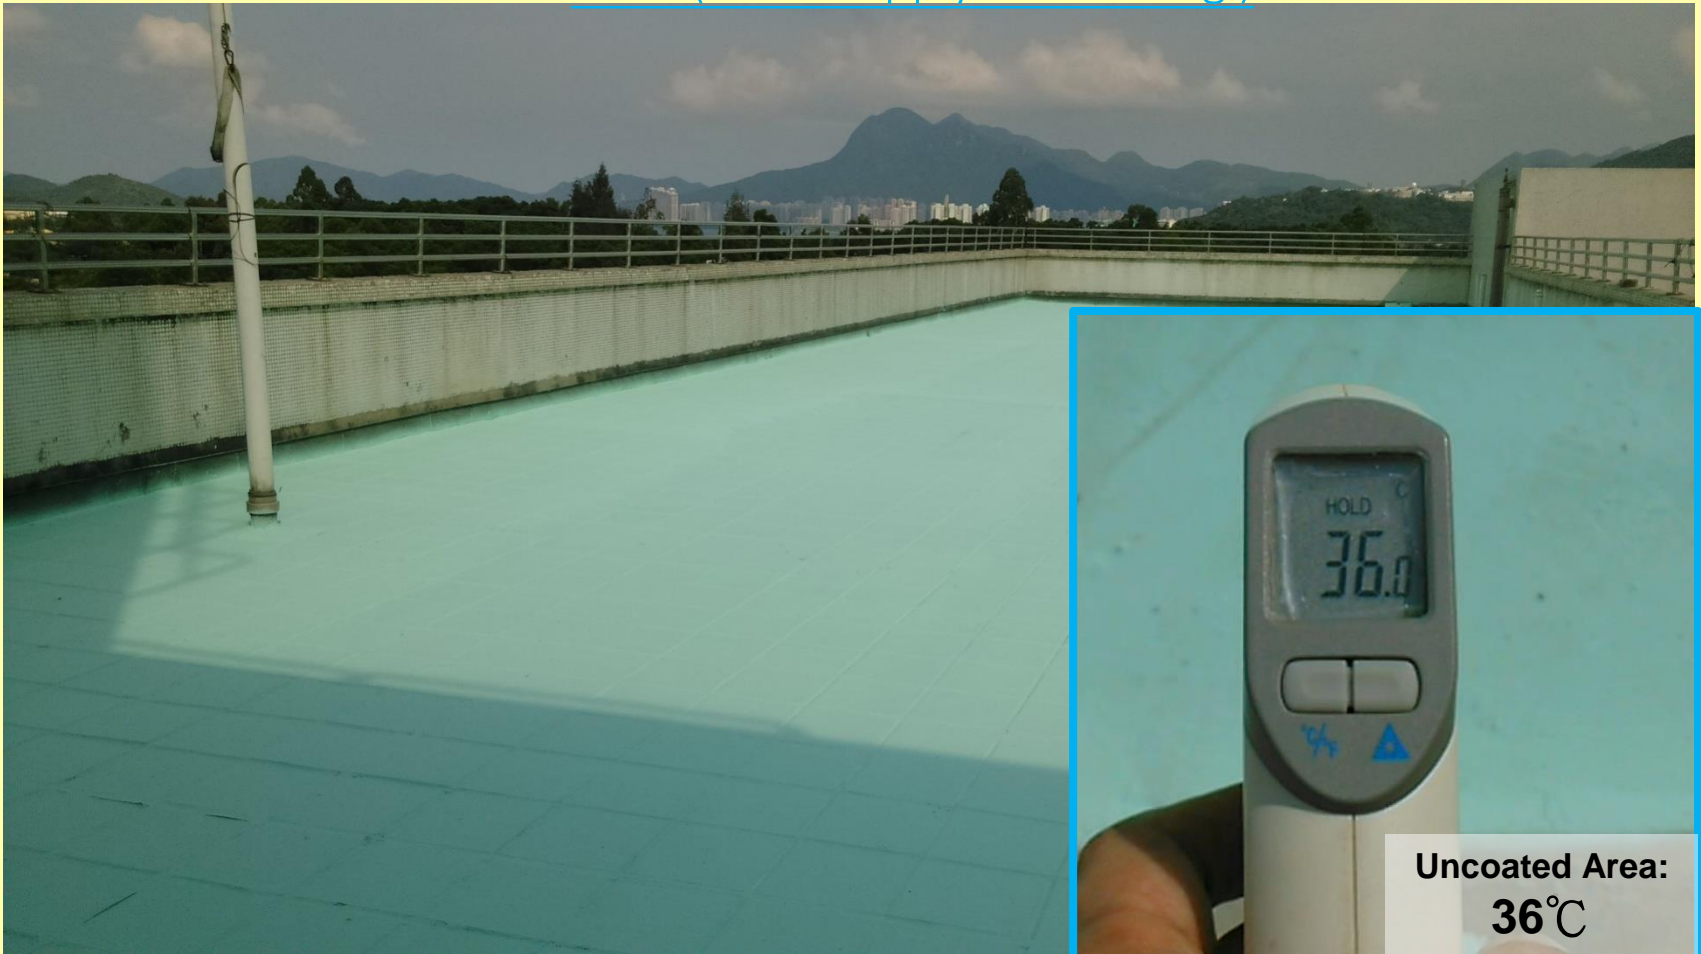
Temp. Test: **After Roof Heat Rejected Coating was applied**

Location: 7/F (School's roof surface)

Temperature Recorded: 33°C (after apply the coating)
35°C (Before apply the coating)

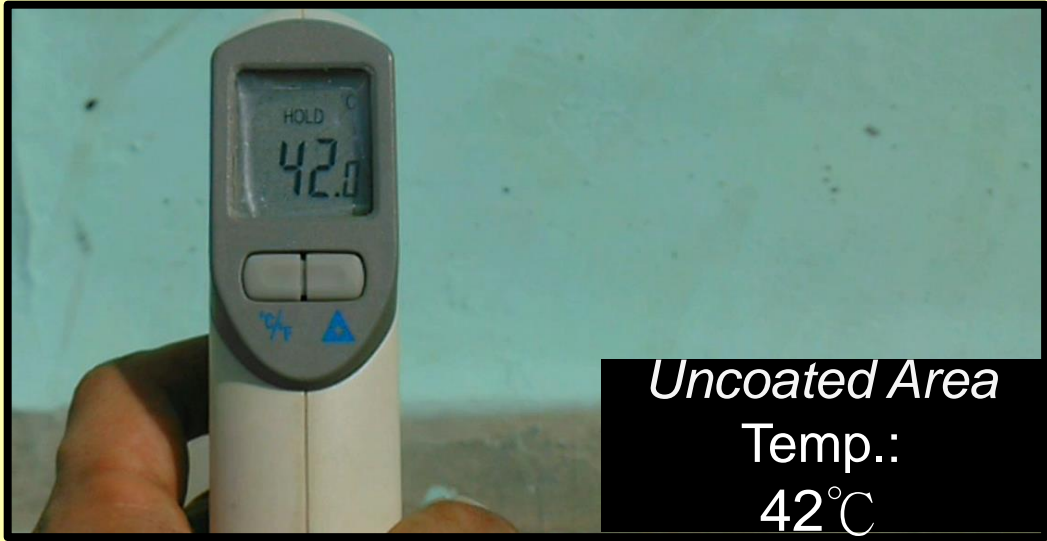
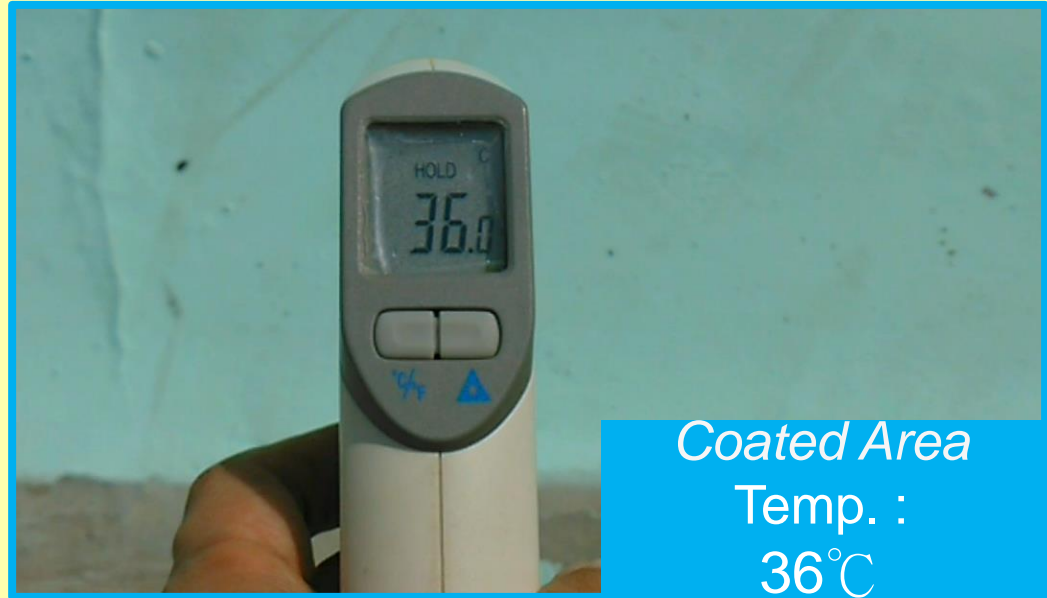
Location: School's roof surface

Temperature Reduced:

6°C
